RESEARCH ARTICLE

CAUSES OF FRACTURE OF METAL ALLOY CHASSIS COBALT-CHROME-MOLYBDENUM (EXPERIMENTAL STUDY)

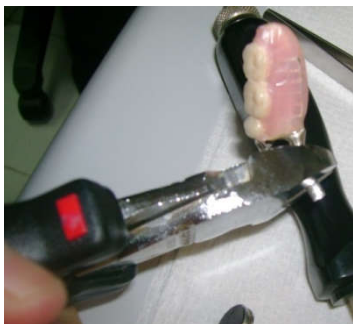
Figure 1. Cutting the sample

a scanning electron microscope. In order to be able to analyze the fractured metal frames, we cut them 1 cm from the fractured area with a cutting pliers (figure 1). Then we put the sample on a sample port using double-sided tape (Figure 2). Afterwards, we brought the two sample holders to the analysis chamber (Figure 3).

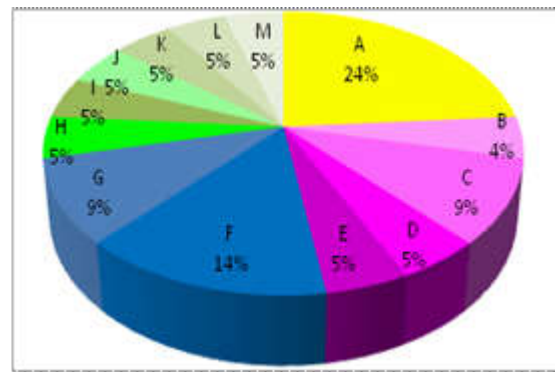
Figure 15. The chemical elements that compose the crack

C: Presence of Co-Cr-Mo alloy elements with [c] high Chromium, [c] lower Cobalt and above normal molybdenum (high) + [c] medium Oxygen + [c] low Carbon.

A: Presence of the elements of the Co-Cr-Mo alloy with a higher [c] of Chromium + [c] low Carbon and Oxygen.

B: Presence of the elements of the Co-Cr-Mo alloy with a high [c] of Molybdenum, lower of Cobalt (average) and normal of Chromium + [c] low of Carbon.

C: Presence of the elements of the Co-Cr-Mo alloy with a high [c] of Chromium, [c] average of Molybdenum and a low [c] of Cobalt + [c] low of Carbon and Oxygen.

D: Presence of the elements of the Co-Cr-Mo alloy with a high [c] of Chromium, [c] average of Cobalt, [c] normal of Molybdenum and [c] low (above normal) of Silicon + [c] low of Carbon + [c] average of Oxygen.

E: Presence of the elements of the Co-Cr-Mo alloy with a high [c] of Chromium, [c] average of Cobalt and a normal [c] of Molybdenum + [c] average of Carbon + [c] low of Oxygen + [c] low of Sodium and Chlorine + [c] low of Calcium + [c] low of Potassium.

F: [c] high Carbon + [c] low Oxygen.

G: [c] high Carbon + [c] average Oxygen + [c] average Calcium.

H: [c] high Carbon + [c] average Oxygen + [c] average Calcium + [c] low Chromium.

I: [c] high Carbon and Oxygen content + [c] average Molybdenum content + [c] average Calcium content.

J: [c] high Carbon and Chlorine + [c] medium Oxygen + [c] low Calcium.

K: [c] high Silicon + [c] low Carbon + [c] low Oxygen.

L: [c] high Oxygen and Molybdenum + [c] average Calcium + [c] low Chromium + [c] low Cobalt + [c] low Carbon.

M: [c] high Aluminium + [c] high Oxygen.

- 52% of the samples show a change in the proportions of the base elements constituting the Co-Cr-Mo alloy at the crack area.
- 63% of the samples show other elements at the crack level than the elements constituting the Co-Cr-Mo alloy.
- 15% of the samples show a change in the proportions of the base elements constituting the Co-Cr-Mo alloy and other elements than the elements constituting the Co-Cr-Mo alloy at the crack level.

So the cause of the cracks is:

- In 52% of the samples is segregation.

- In 63% of the samples is porosity.

- In 15% of the samples is segregation and porosity.

To reduce the fracture rate of Co-Cr-Mo alloy metal chassis, it is necessary to try to reduce the quantity of structural defects by strictly respecting the technique chosen for casting the metal chassis and improving the casting techniques of the Co-Cr-Mo alloy. Wherever possible, use induction vacuum or neutral gas flux casting (Argon) and depressed-pressure casting which provide the low structural defect rate in the cast part.
